Manhole Inspection Summary

Manhole # S250__021MH

Insp Date: **4/2/08 10:53 AM**

Location Address: **1501 Bush St**

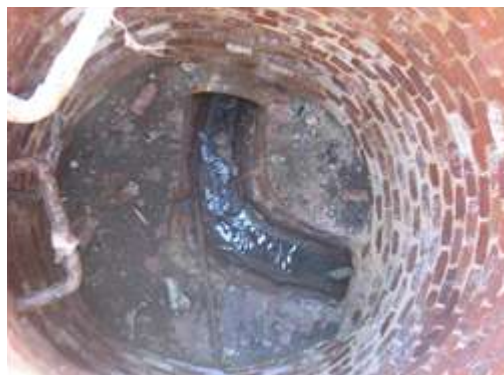
Top View

Condition: ☐ Sound ☐ Cracked ☐ Root Intrusion ☒ **Deteriorated** ☐ Leaks ☒ **Debris**

Debris on bench

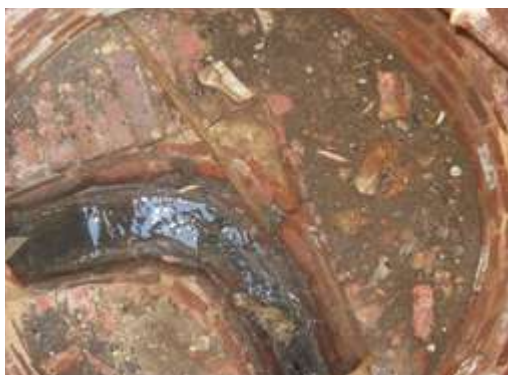
Defect 3

Condition: ☐ Sound ☐ Cracked ☐ Root Intrusion ☒ **Deteriorated** ☐ Leaks ☒ **Debris**

Bench and Channel debris and deterioration

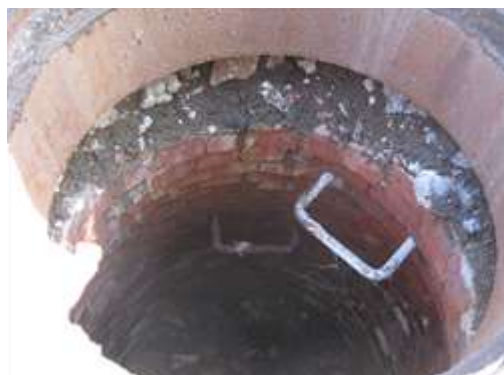
Defect 2

Frame Offset: **3** (in.) Condition: ☐ Sound ☐ Cracked ☒ **Leaks**

Condition: ☐ Sound ☐ Cracked ☐ Root Intrusion ☒ **Loose Brick** ☒ **Deteriorated**

Missing bricks and mortar, loose bricks, deteriorating chimney, 3" frame offset, frame leaks

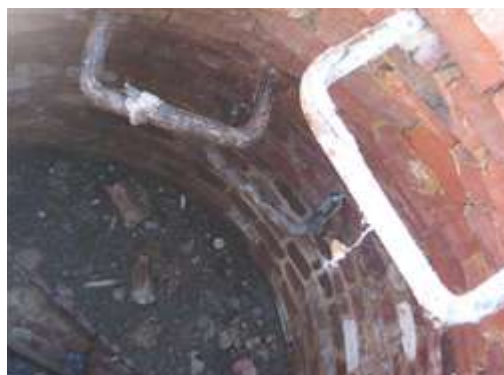
Defect 1

Steps Count: **3** Missing: **0** ☒ **Corroded**

corroded Steps

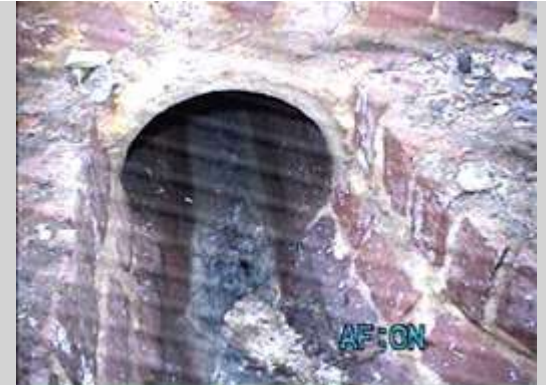
12 O'Clock Outflow

Debris in channel
